Marks of the Ordnance Survey

Wilson, P. (2021, Oct 9). Marks of the Ordnance Survey. Portrush Heritage Group: Heritage Newsletter.

Marks of the Ordnance Survey by Dr Peter Wilson

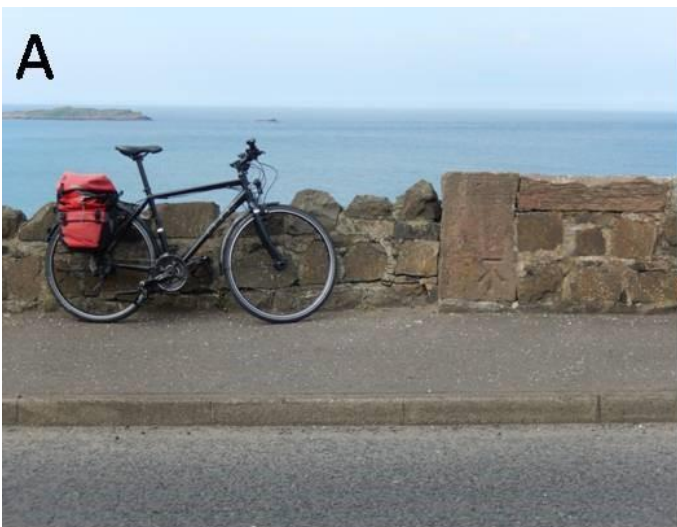
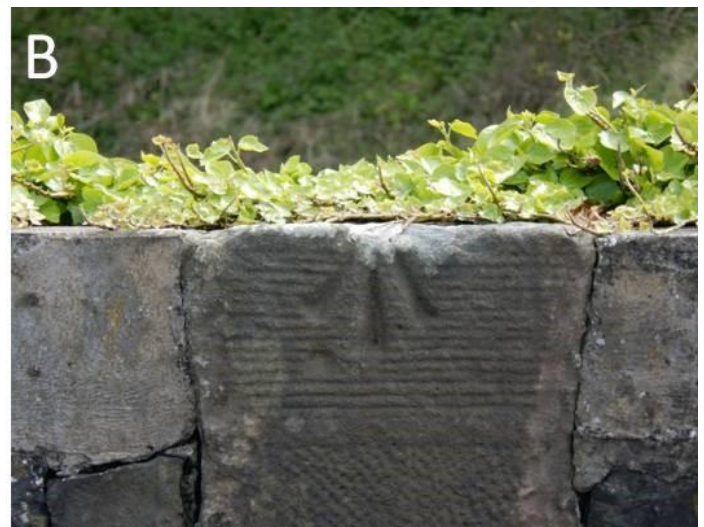
A. Long Gilbert Bridge: bench mark at base of sandstone block on south-facing parapet. B. Long Gilbert Bridge: bench mark arrow at top of sandstone block on north-facing parapet.

The other two bench marks I have found are both on Long Gilbert Bridge, Dunluce Road. The bridge is not immediately obvious when driving along that road but is towards the eastern end of Long Gilbert Quarry and is indicated by a slight rise in the height of the roadside walls and the inclusion of some sandstone blocks between the basalt blocks. The bridge carries the road across a gully. The most prominent of the two bench marks is that on the south-facing side of the north

parapet at the base of a sandstone block. The other is across the road on the north-facing side of the south parapet and is also on a sandstone block. However, this arrow has been cut close to the top of the block so that the upper surface of the block replaced the need for a horizontal cut mark. It is unusual to have two bench marks so close together and virtually opposite one another. No doubt there was a reason behind this.

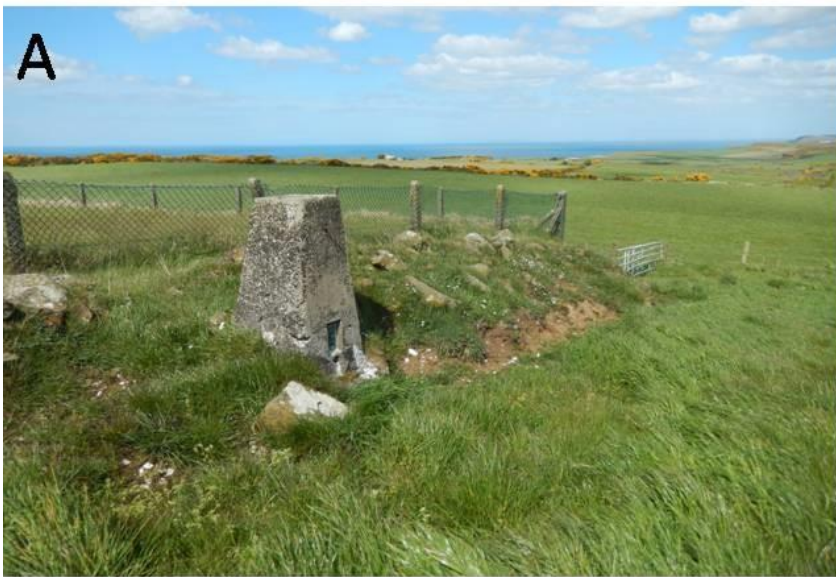
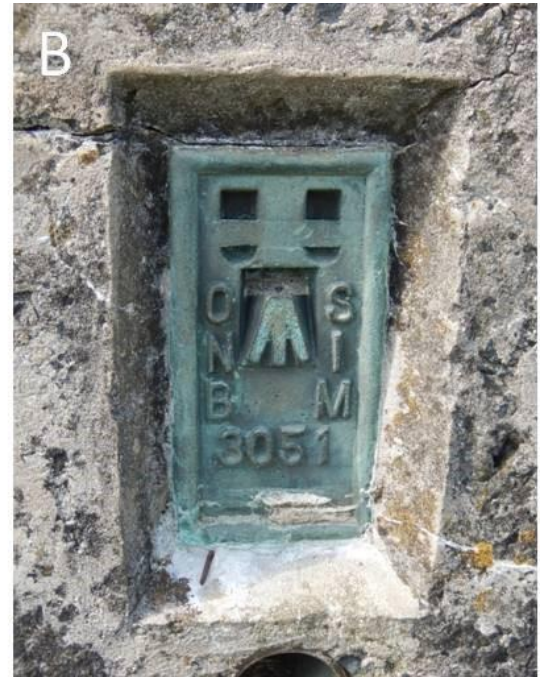
A. Scudion Craig trig pillar. B. Flush bracket on Scudion Craig trig pillar.

In 1950 the OSNI commenced work on a re-triangulation of the province in order to provide a basis for a new series of large-scale maps. A consequence of this was the construction of triangulation stations – generally known as trig pillars or trig points – on many hill-tops. These take the form of a truncated concrete pyramid about 1.2 m high and 0.6 m square at the base. Fixed to the top of each pillar is a brass ‘spider’ with three legs 120° apart upon which a theodolite can be mounted for surveying purposes. On one side of the pillar a rectangular metal plate called a flush bracket (‘flush’ with the face of the pillar) is normally present. The flush bracket carries a bench mark. Flush brackets were sometimes placed on walls and buildings but I do not know of any such in Portrush. Perhaps the nearest example is Coleraine Town Hall, although some years ago an electricity box was placed against the wall, effectively obscuring the bracket!

The only trig pillar I know of in Portrush is at Scudion Craig - a very short distance east of the highest point of Ballyhome Road at 132 m above sea level - but not visible from the road. It is marked on the 1:50,000 and 1:25,000 scale maps by a small triangle with a dot in the middle. The flush

bracket is slightly recessed rather than being 'flush', has a horizontal slot with an arrow directly beneath, and bears the letters OSNI BM and the number 3051.

Also on the top of this trig pillar is a small round-headed brass rivet. This was added in the 1990s as OSNI switched from using trig pillars and bench marks to Active and Passive GPS stations. Scudion Craig functions as a Passive Station, meaning that it continues to be part of the network of ground marks with precisely measured co-ordinates. The bench mark on the flush bracket is now defunct.
